Re: **LIMITED VISUAL CONDITION ASSESSMENT SERVICES**  
Ross S. Sterling High School  
300 W Baker Rd  
Baytown, TX 77520  
Terracon Project No. F3226076

## Limited Structural Visual Condition Assessment Services

Re: LIMITED VISUAL CONDITION ASSESSMENT SERVICES  
Ross S. Sterling High School - Phase 2  
300 W Baker Rd  
Baytown, TX 77520  
Terracon Project No. F3226076

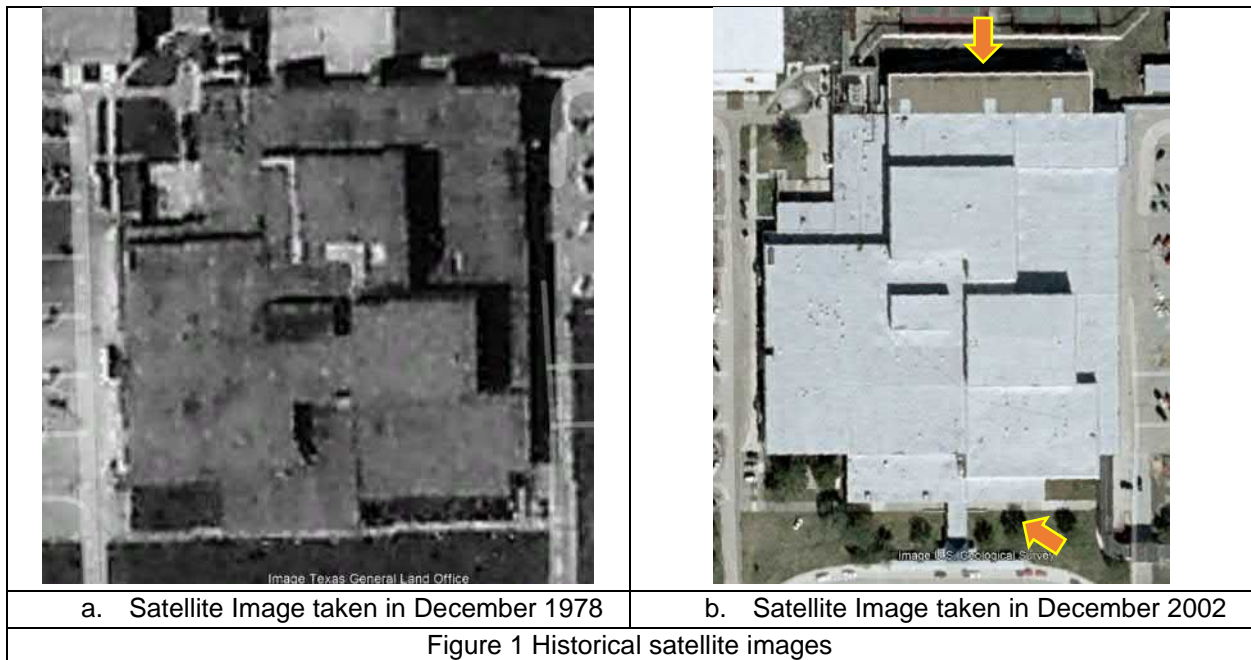
- Based on our review of the historical satellite images obtained from Google Earth®, we identified two structures that were added to the north side and the south side of the primary school building between 1978 and 2002. It is possible that the structure added to the north side of the building might have changed the performance of ventilation openings on the north side of the original building.
