Goose Creek 2035 Committee

| SEPTEMBER 24, 2024

GC2035 COMMITTEE MEETING NO. 3

GOOSE CREEK CONSOLIDATED ISD

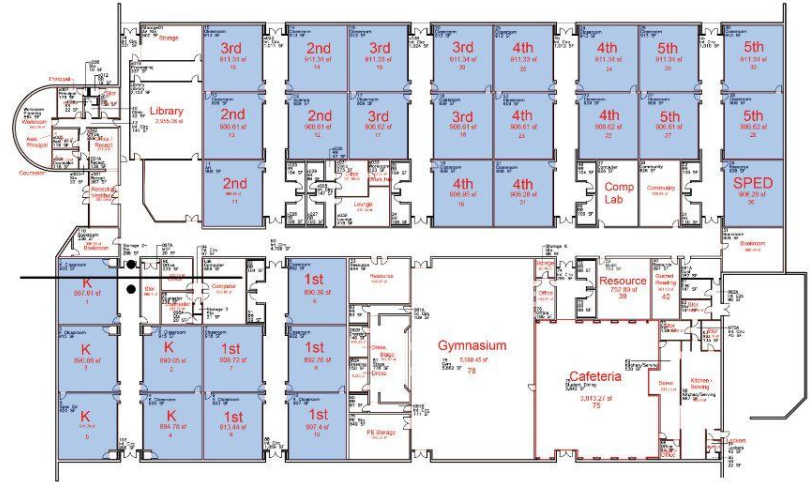
Functional Capacity Vs Maximum Capacity - Elementary Schools

Maximum Capacity = Teaching Stations (TS) X Capacity of the Room*

Functional Capacity (ES) = Maximum Capacity X 0.9

There are 29 teaching stations (**TS**) highlighted on the plan.
 $29 \text{ TS} \times 22 \text{ students/TS} = 638 \text{ student Maximum Capacity}$
 $638 \text{ students} \times 0.90 = 574 \text{ Functional Capacity}$

*Capacity of Rooms : 25 Typical, 24 or 28 for Science, 50 for Gymnasiums and Band Halls, Specialized Rooms (CTE, Life Skills, Etc.) possibly less than 25

** Capacity of room can be affected by the actual square footage of rooms

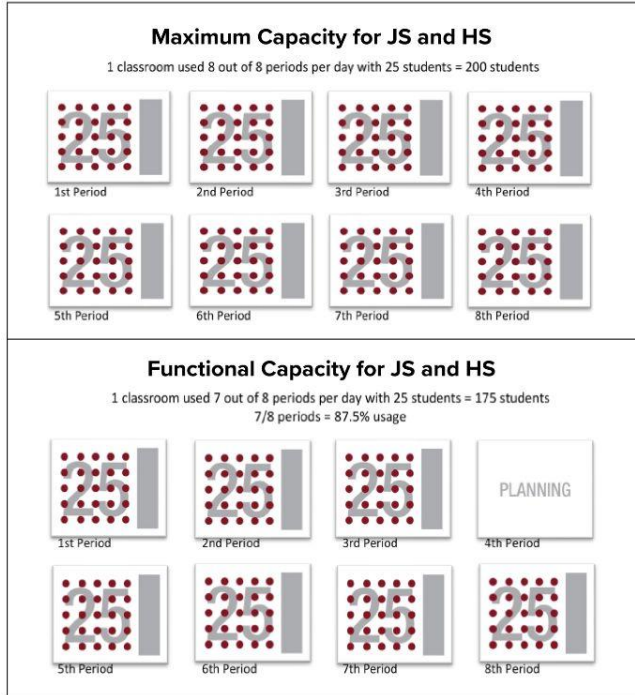
Functional Capacity Vs Maximum Capacity - Junior and High Schools

$$\text{Maximum Capacity} = \text{Teaching Stations (TS)} \times \text{Capacity of the Room}^*$$

$$\text{Functional Capacity (JS \& HS)} = \text{Maximum Capacity} \times .875$$

*Capacity of Rooms : 25 Typical, 24 or 28 for Science, 50 for Gymnasiums and Band Halls, Specialized Rooms (CTE, Life Skills, Etc.) possibly less than 25 for safety reasons or program requirements.

** Capacity of room can be affected by the actual square footage of rooms into empty classrooms.

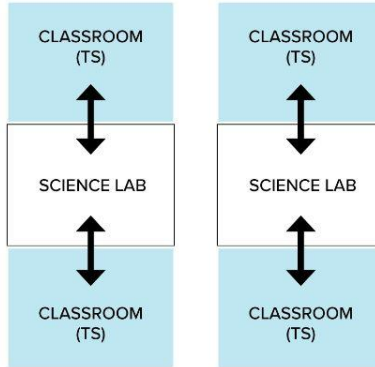
4 Science Classrooms & 2 Science Labs

4 Teaching Stations (Classrooms) are counted for capacity. If a Science Lab is being used, there is a corresponding empty classroom. Each Science Lab is shared with 2 classrooms.

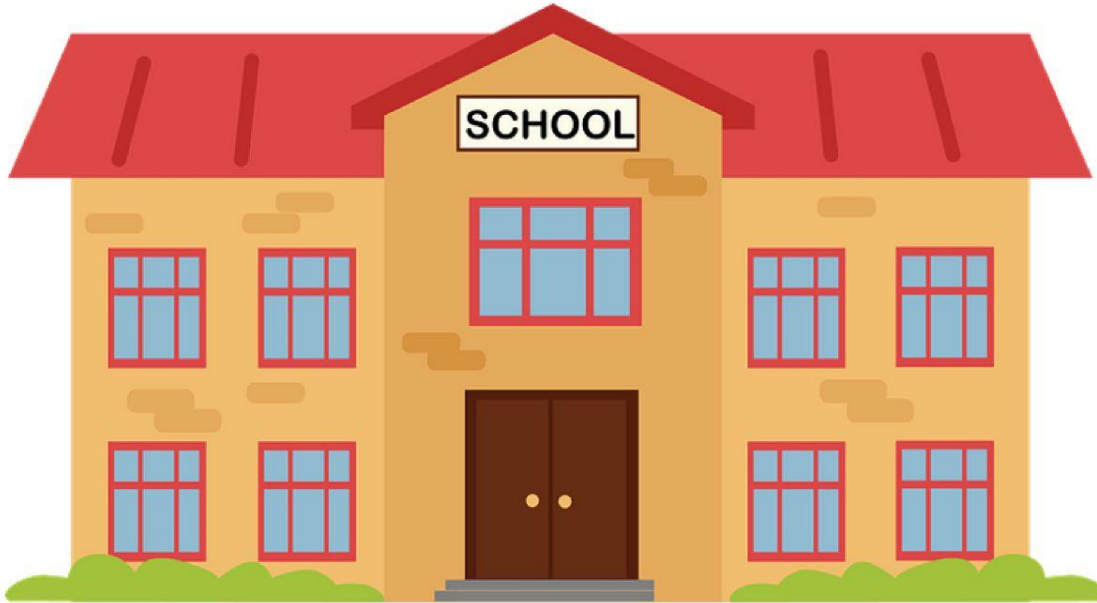
**Building
Replacement = \$100,00
Value**

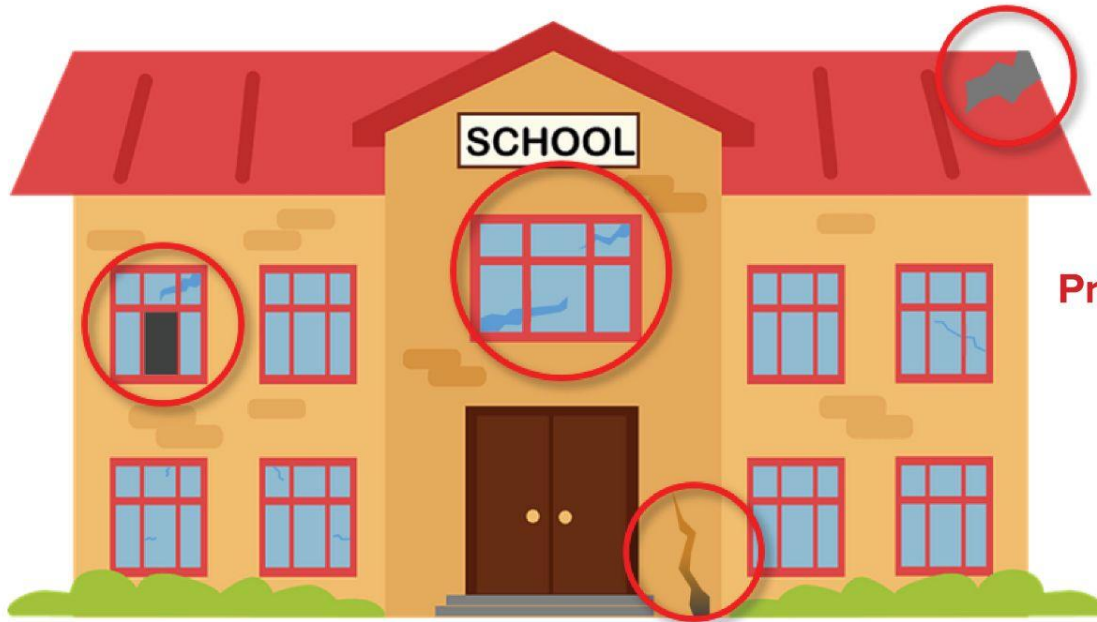
$$\begin{array}{r} \text{Priority 1 Requirements} = \$15,000 \\ \hline \text{Value} = \$100,000 \end{array}$$

$$\text{FCI} = .15 \text{ (15\%)}$$

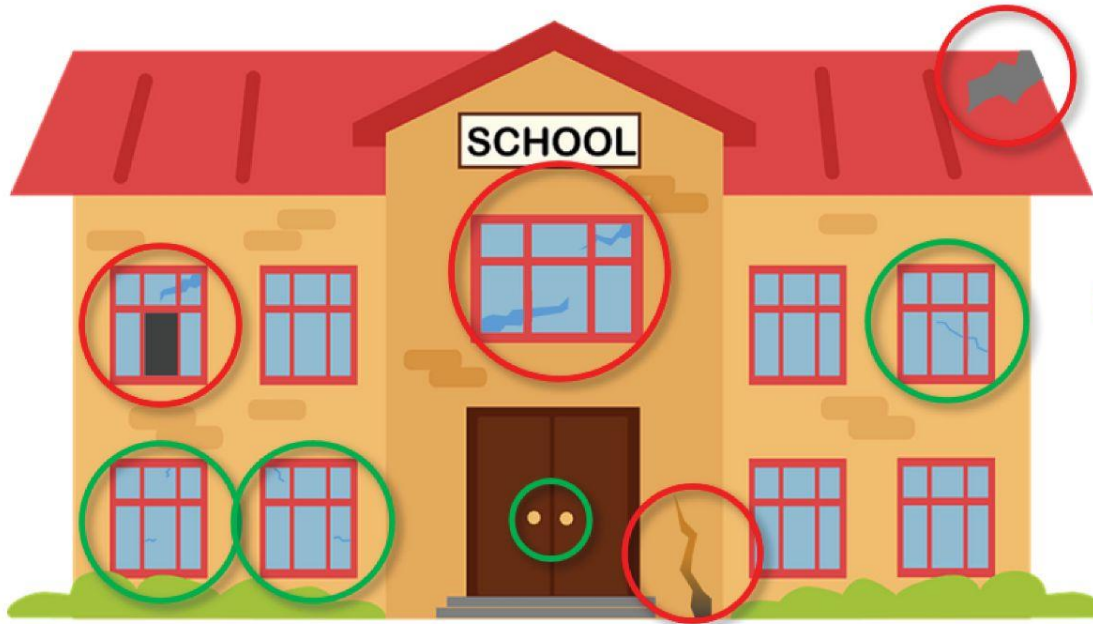
Priority 1
Requirements = \$15,000

Priority 2 + 3 (5 yrs)
Requirements = \$30,000

Value = \$100,000

RI = .45 (45%)

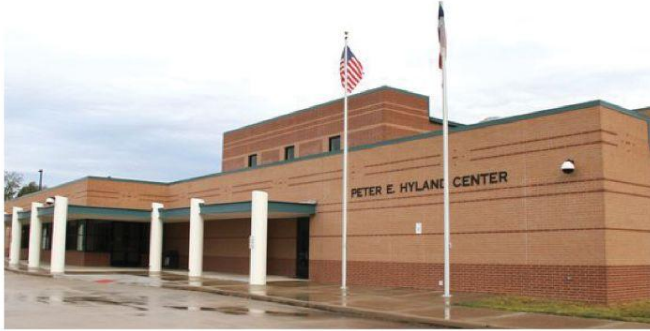
PETER E. HYLAND CENTER - ALTERNATIVE HIGH SCHOOL - Main Building

- Restroom Renovations
- School Equipment Replacement
- Floor Finish Replacement
- Roof Replacement

- Fire Alarm System Replacement
- Security System Replacement
- Public Address System Replacement
- Egress Signage Replacement
- Emergency Battery Pack Lighting Replacement
- Mechanical System Improvements
- Kitchen Exhaust / Suppression System Replacement
- Electrical System Improvements
- Ceiling Replacements
- Kitchen Equipment Replacement
- Wall Finish Replacement
- Water Fountain Replacement

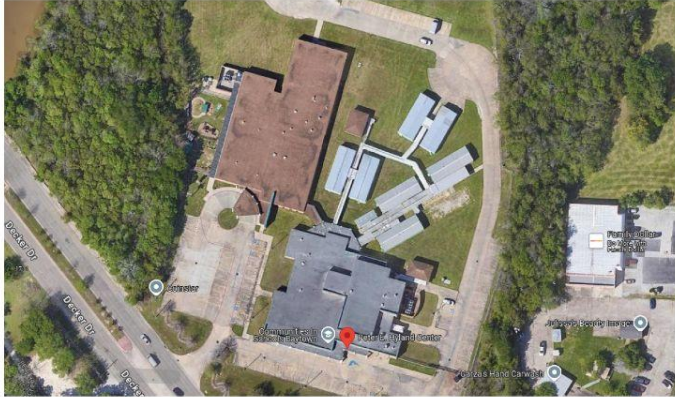
PETER E. HYLAND CENTER - ALTERNATIVE HIGH SCHOOL - Site

Fencing/Gate Replacement

Storm Sewer Inlet Repairs

Exterior Pole Mounted Light Replacement

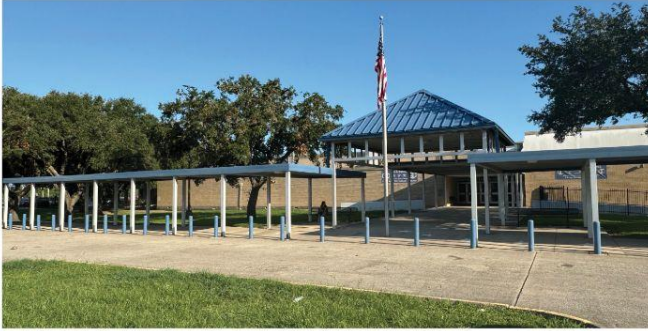
STERLING HIGH SCHOOL - Main Building

Structural steel replacement

Painting
Carpet replacement
Locker removal
Door replacement
Room signage replacements
Exterior signage replacement
Canopy replacement

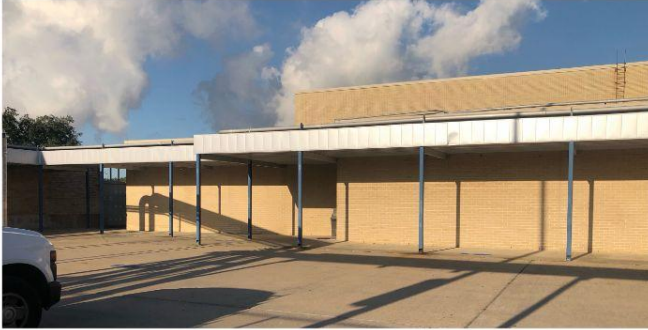
STERLING HIGH SCHOOL - Natatorium

- Fire Alarm System Replacement
- Egress Signage Replacement
- Emergency Batter Pack Lighting Replacement
- Translucent Roof Panel Replacement
- Electrical System Improvements
- Plumbing System and Fixture Replacement
- Pool Equipment Replacement
- Sanitary Waste System Improvement
- Floor Finish Replacement or Repairs
- Hard Ceiling Repairs and Refinish
- Interior Door Replacement

- Gym Bleachers Replacement
- Window Replacement
- Exterior Metal Panel Replacement
- Exterior Door Replacement
- Interior Lighting Improvement
- Security System Replacement
- Communication System & Public Address System Replacement
- Mechanical and Exhaust System Improvement
- Exterior Brick Pavement Replacement

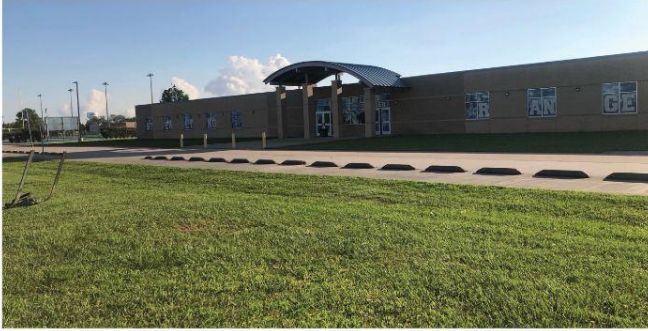
STERLING HIGH SCHOOL - Ranger Athletic Facility

- Fire Alarm System Replacement
- Public Address System Replacement
- Emergency Batter Pack Lighting

- Security System Replacement
- Exit Signage Replacement
- Electrical System Improvement
- Mechanical and Exhaust System Improvement
- Plumbing System Improvement
- Interior Lighting Improvements
- Roof Replacement
- Ceiling Replacement
- Restroom Renovations
- Folding Partition Improvement
- Interior Wall Finishes
- Interior Floor Finish Replacement
- Kitchen Cabinet Replacement
- Exterior Door Replacement

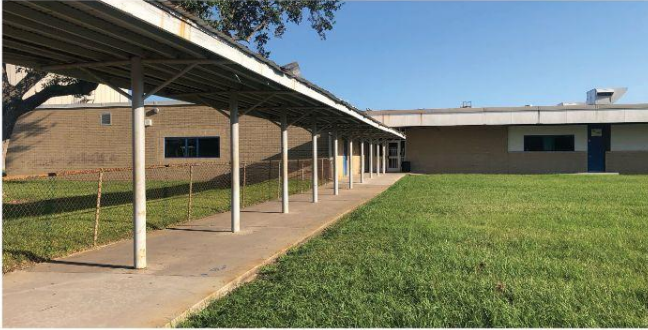
STERLING HIGH SCHOOL - Vocational / ROTC / Agriculture Building

- Fire Alarm System Replacement
- Emergency Batter Pack Lighting Replacement
- Restroom Renovations
- Roof Replacement
- Ceiling Replacement
- Interior Door Replacement
- Floor Finish Replacement
- Terrazzo Floor Replacement
- Water heater Replacement
- Folding Partition Replacement
- Interior Wall Finish Improvements
- Kitchenette Replacement

- Electrical System Improvement
- Mechanical System Improvement
- Plumbing System and Fixture Improvement
- Exhaust System Replacement
- Sanitary System Improvement
- Egress Signage Replacement
- Security System Replacement
- Communications System Improvement
- Public Address System Replacement
- Metal Roofing Replacement
- Cabinet Replacement
- Exterior Door Replacement

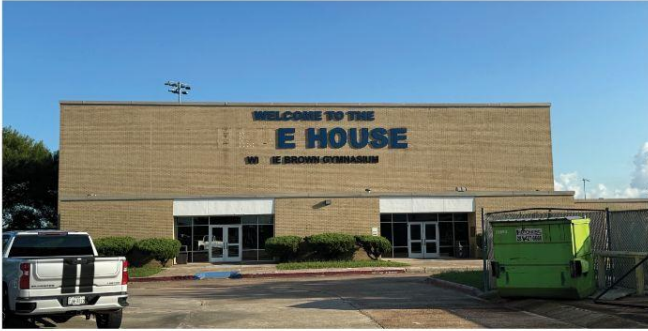
STERLING HIGH SCHOOL - Winnie Brown Gymnasium

- Fire Alarm System Replacement
- Roof Replacement
- Interior Wall Painting
- Interior Door Replacement
- Public Address System Replacement
- Restroom Renovations
- Ceiling Replacement
- Floor Finish Replacement
- Terrazzo Floor Replacement
- Emergency Battery Pack Lighting Replacement

- Electrical System Improvement
- Mechanical System Improvement
- Plumbing System & Fixture Improvement
- Sanitary Waste System Improvement
- Exhaust System Replacement
- Wood Floor Replacement
- Roof Drainage Improvement
- Egress Signage Replacement

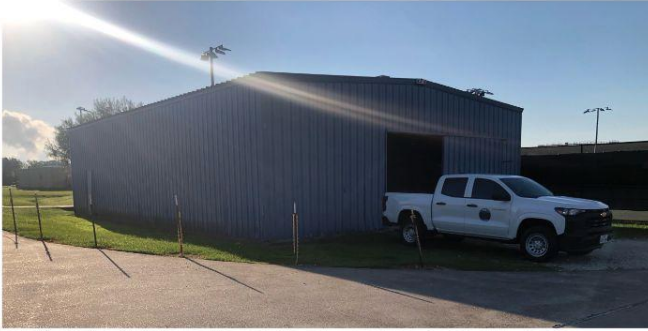
STERLING HIGH SCHOOL - Grounds Storage Building

- Metal Roofing Replacement
- Exterior Metal Wall Panel Replacement
- Exterior Door Replacement
- Exterior Overhead Rolling Door Replacement
- Steel Framed Roof Structure Replacement

- Light Fixture Replacement
- Structural Slab-On-Grade Repairs

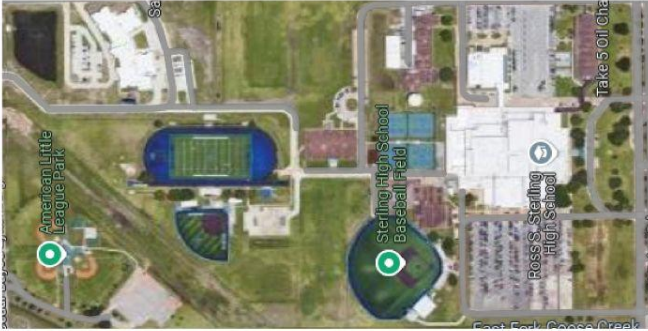
STERLING HIGH SCHOOL - Site

- Concrete Pavement Repairs and Replacement
- Tennis Court Wood Bleacher Replacement
- Soccer Goal Replacement
- Sewer Piping Replacement

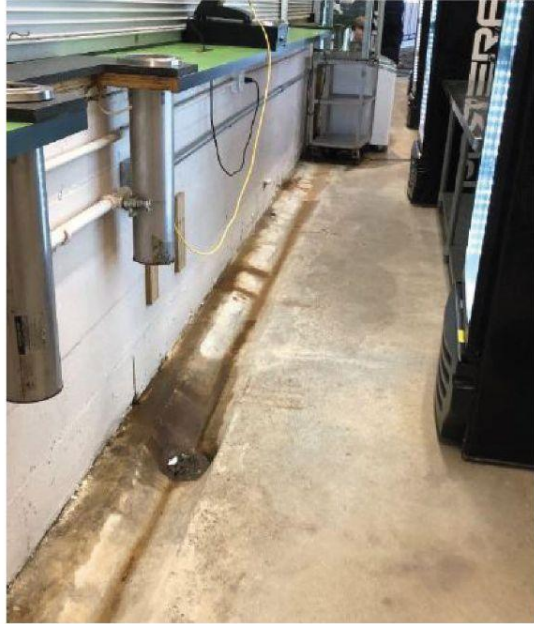
Priority 1

- CMU & Concrete Wall Repairs
- Electrical Distribution System Improvements
- Emergency Lighting Replacement
- Non ADA Compliant Ramps
- Raker Beam Repairs
- Concrete Seat Cleaning, Sealing and Repainting
- Steel Siding Replacement
- CMU Interior Wall Repairs
- Elevator Replacement
- Press Box Replacement
- Plumbing Fixture Replacement
- Fire Alarm Systems Replacement
- Concourse Drainage Improvement

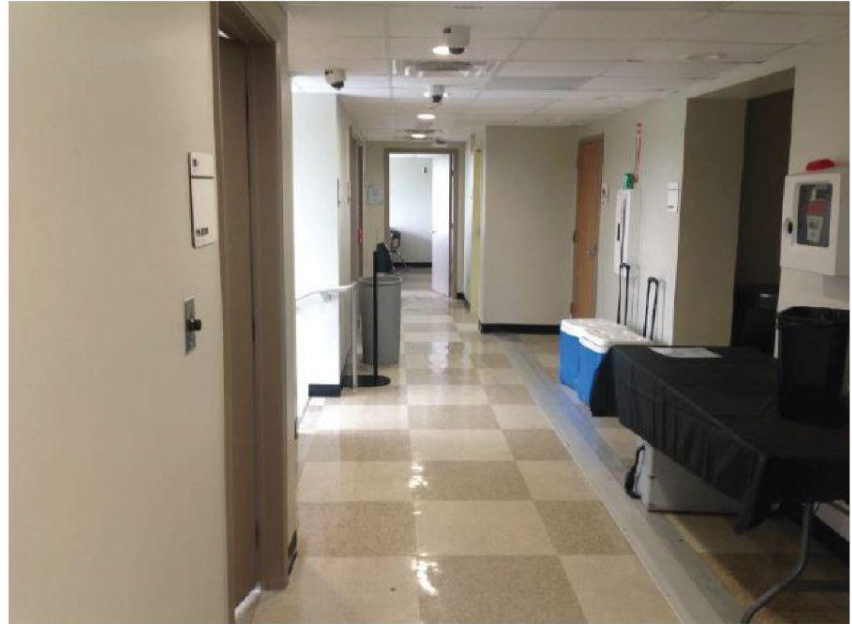
Priority 2

- CMU Wall Painting
- Fencing Repair/Replacement
- Bleacher Seat Replacement
- Synthetic Turf Replacement
